**Conservancy Filter Marsh Project
FDEP Agreement No: G0253**

September 2014

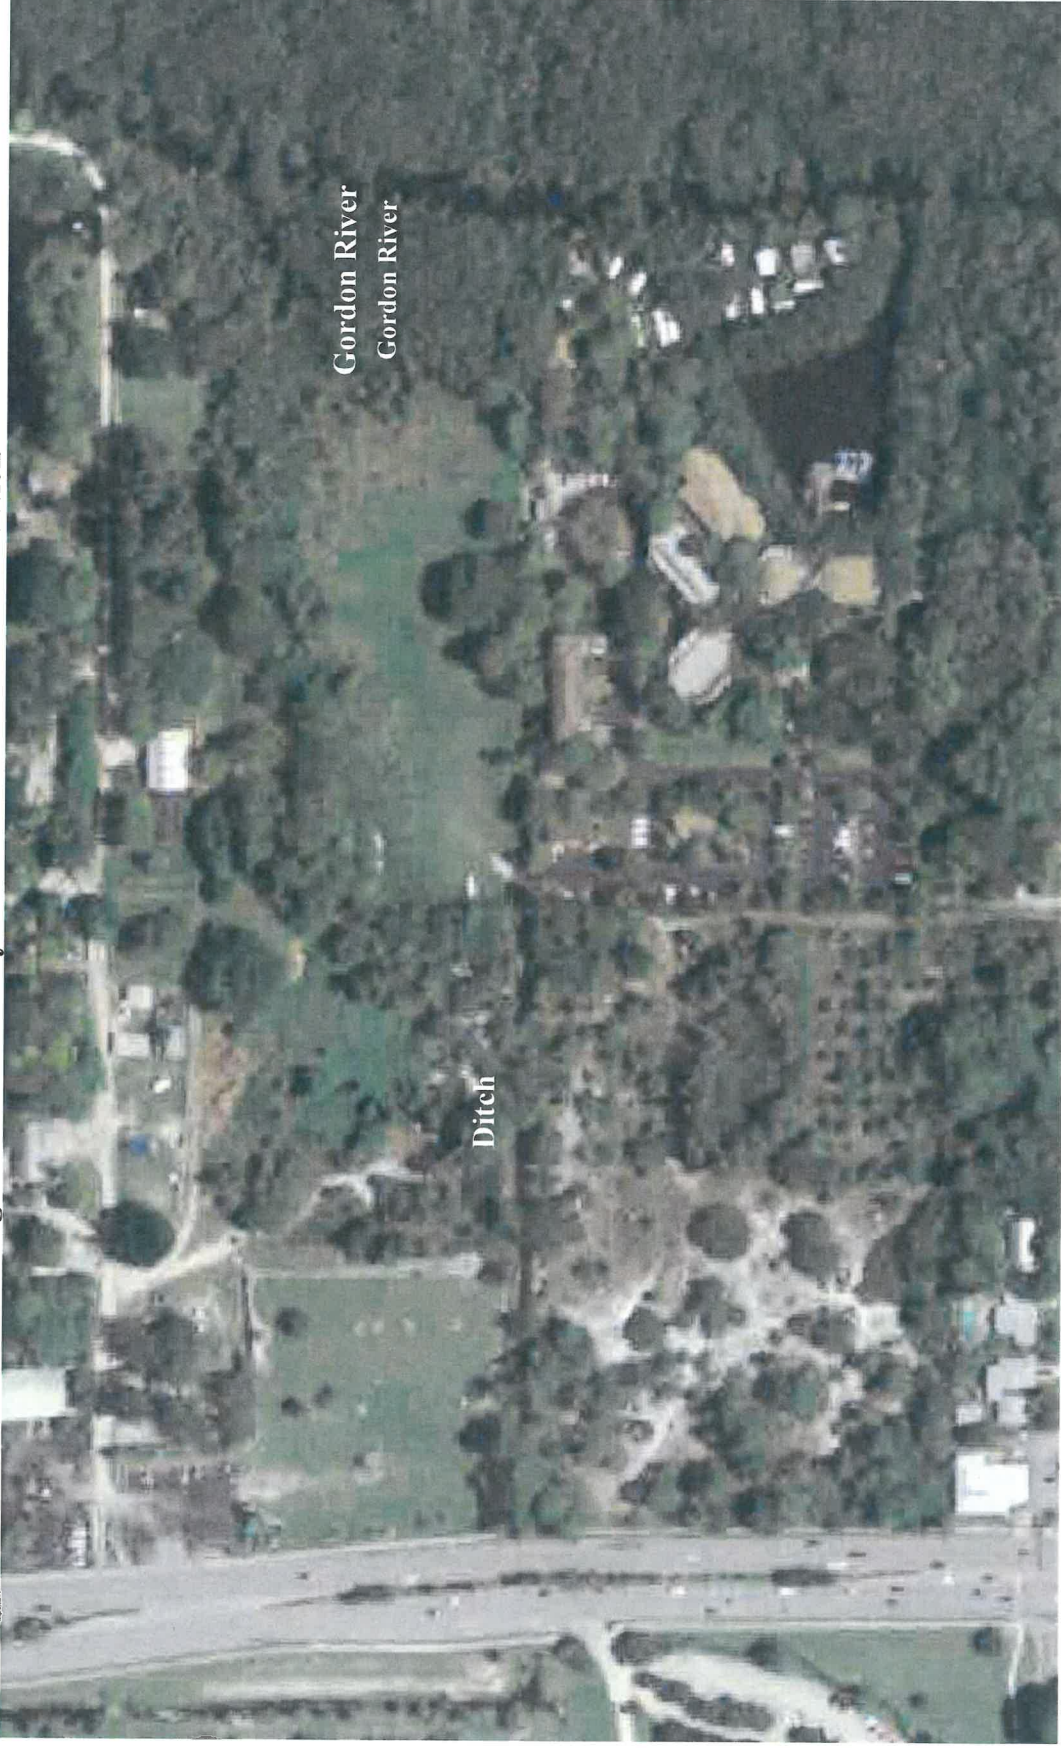
Figure 5: Conservancy Filter Marsh Site Pre-Construction

Prior to the construction of the Conservancy's Filter Marsh, a ditch drained stormwater runoff from a mall parking lot, a major road, and adjacent residential areas, bisected the Conservancy's property and discharged into the Gordon River (Figure 5). In effort to try to reduce pollutants and slow down the volume of stormwater runoff in the ditch the Conservancy intercepted the stormwater flow in the drainage ditch and diverted the flow into a wet detention pond, which in turn, drained into a filter marsh prior to returning to the ditch and ultimately discharging into the river (Figure.6).

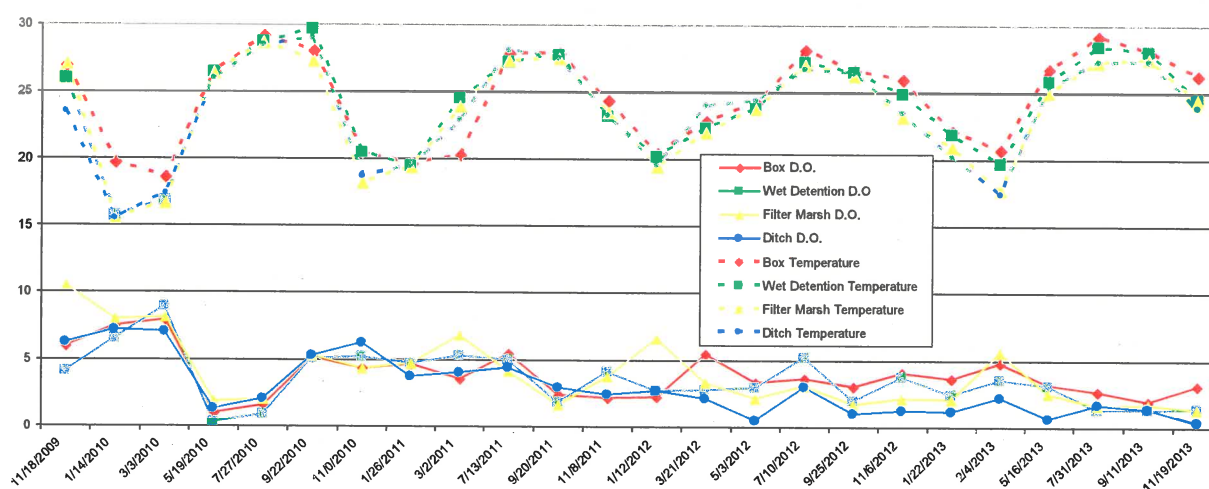
Figure 26: Water Temperature vs Dissolved Oxygen Levels

Temperature is a factor that affects the amount of dissolved oxygen present in waterways. Dissolved oxygen has an inverse relationship with temperature. As expected, due to the inverse relationship between water temperature and dissolved oxygen, during the summer when water temperatures increased, dissolved oxygen decreased in most cases, and this trend was reversed during the winter due to normal seasonal temperature patterns (Figure 26).
